Name of Dam: Horners Dam

Location: Westmoreland County, State of Virginia

Inventory Number: VA 19305 ✓

PHASE I INSPECTION REPORT

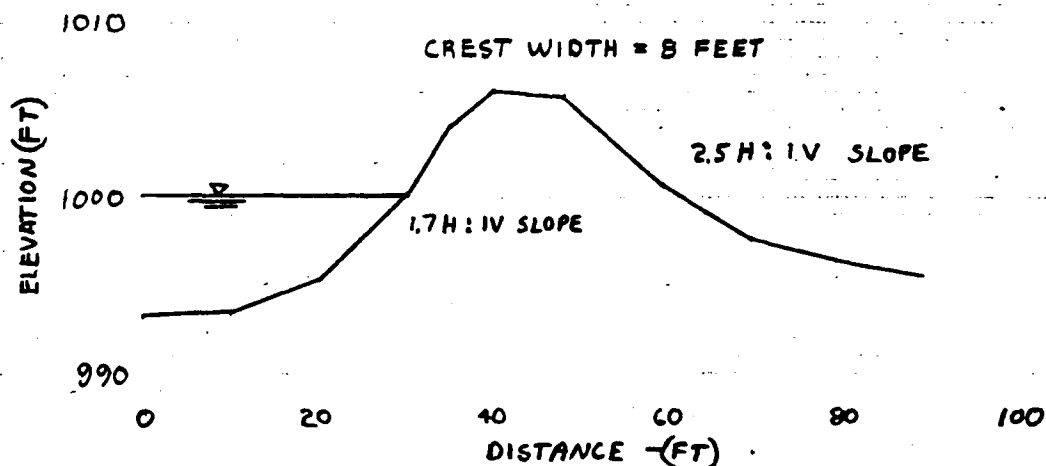
DAM CROSS SECTION AT STA. 4+60

At Station 4+60, located about 120 feet from the right abutment, the downstream slope was observed to be 2.5H:1V. The slope at this location is representative of the embankment in general. The upstream slope at Station 4+60 was found to be 1.7H:1V. Based on inspection of the dam spillways and appurtenances, the dam does not appear to have facilities for draining the reservoir in the event of an emergency, and is thus not considered susceptible to sudden drawdown.
